# Home Inspection Report

## Secure Home Inspections, Inc.

Property Address: 1028 Sample Dr.  
Conway, SC

Date: 07/17/2000

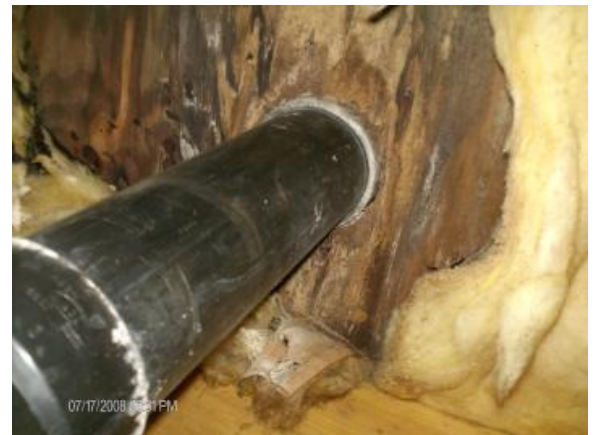
1. Acceptable Structure Type: Wood frame
2. Acceptable Foundation: Block Piers
3. Acceptable, Repair Subfloor: Plywood>  
> Moisture stains and/or damage is visible from recent bathroom leaks, service for possible repair by a qualified contractor is recommended.

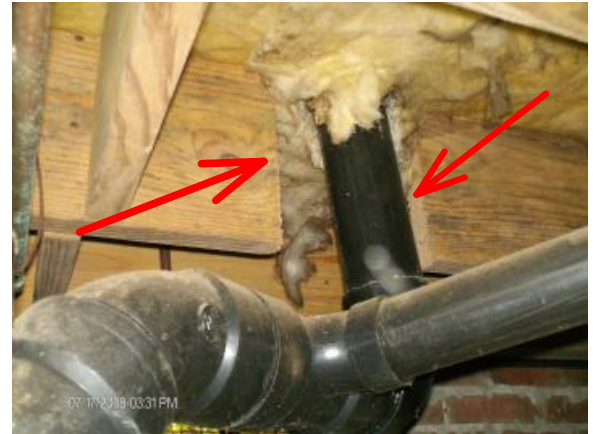
> Altered floor joist is noted around the middle bathroom plumbing, further evaluation for corrective measures by a qualified contractor to insure proper long term service of the system is recommended.

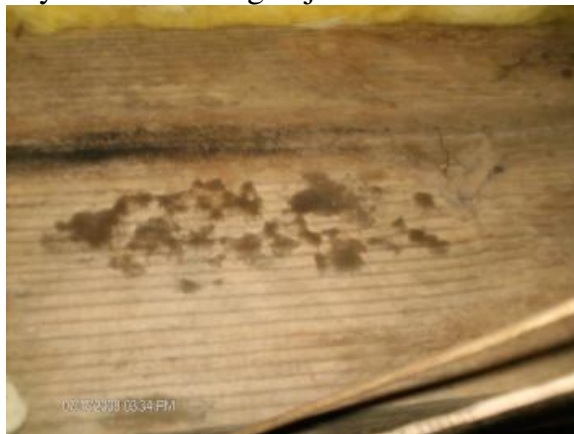
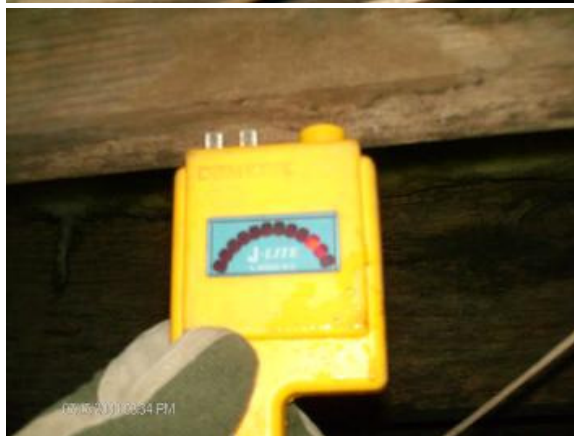
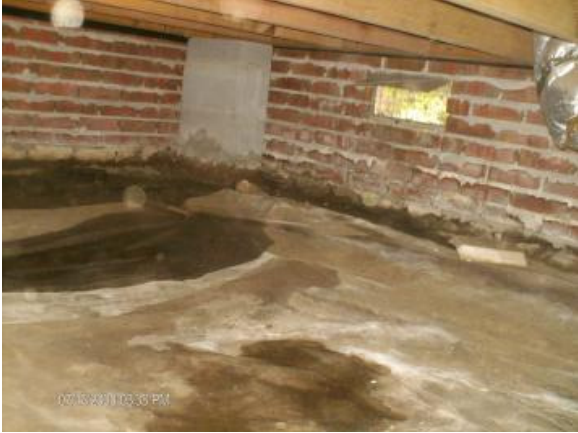
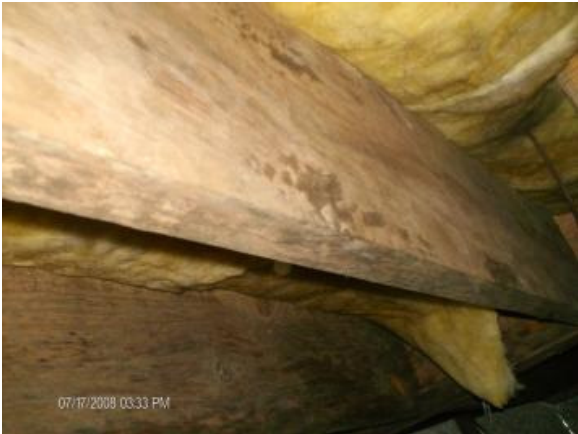
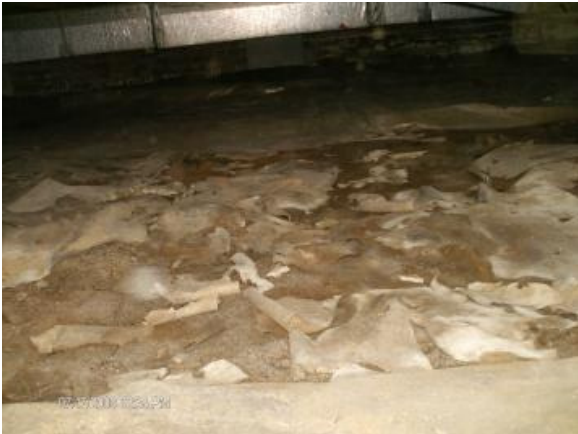
**Moisture Penetration:** Elevated moisture in crawlspace is a conducive condition for insect issues and you should consider a full pest evaluation to insure no issues exist.

> Elevated moisture levels are noted in the crawlspace and some evidence a fungal like growth is visible in some areas of the joist structure with some deterioration taking place, further evaluation of the crawlspace by a qualified contractor or moisture control contractor for corrective measures is recommended. Vapor barrier under home is damaged and is not serviceable. See final comments for additional information.

\*\*While drainage around the foundation is part of the affect to the moisture levels under the home, you have a duct system with cooled air flow in the system and open foundation vents allowing super heated air to enter the area. This is a sub tropical condition that has become a known issue in the last few years and advances in crawlspace systems has and can easily correct this condition under the home other than any surface damaged joist.

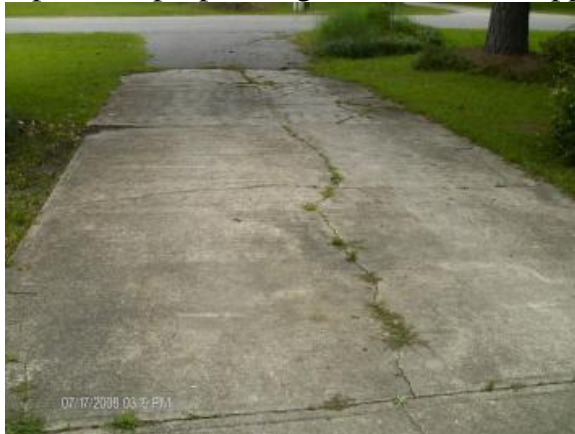
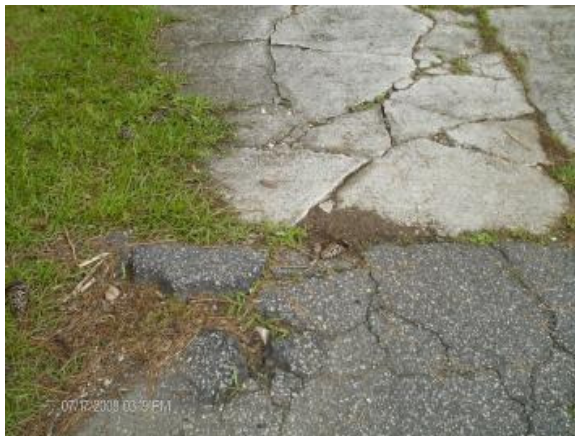
1. Acceptable, Repair Driveway: Concrete, Common cracks are visible in a couple areas and you should consider basic sealant over cracks when noted to prevent future penetration and damage.  
>Heavy cracks in surface due to age and heaving from nearby tree roots, service for repair and proper long term service. Tripping hazard is also present.

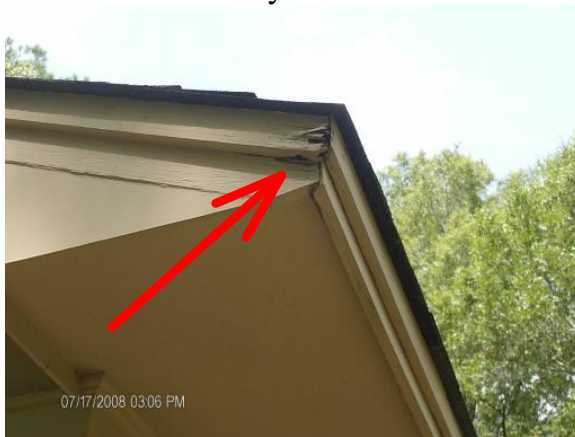
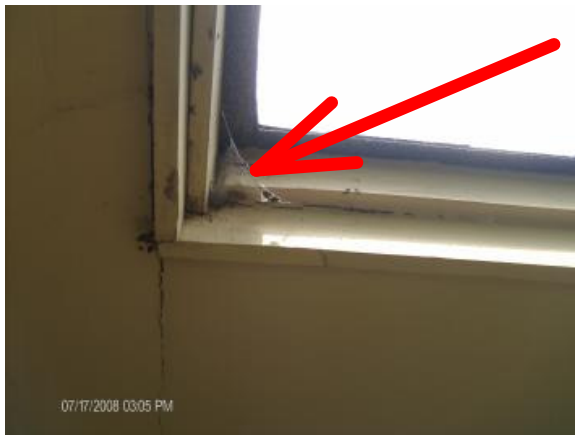
> Water damage is visible in a few small sections of the front, left & rear fascia, evaluation by a qualified contractor for corrective measures as possible hidden moisture issues may exist at this time.

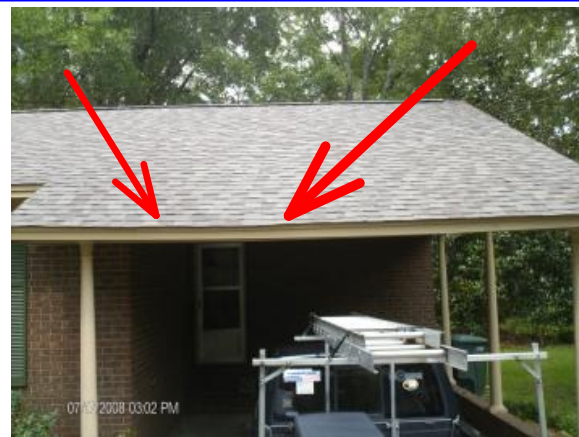
> Sagging is visible in a small section of the front eave over the carport drive area and is visible in the roof line, evaluation by a qualified contractor is recommended to insure proper long term service of the section.

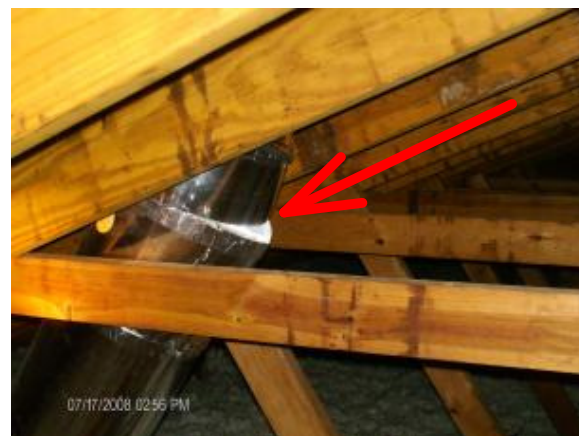
> Solar tube is disconnected in the attic near the roof, evaluation by a qualified contractor for repair is recommended to insure proper long term service.

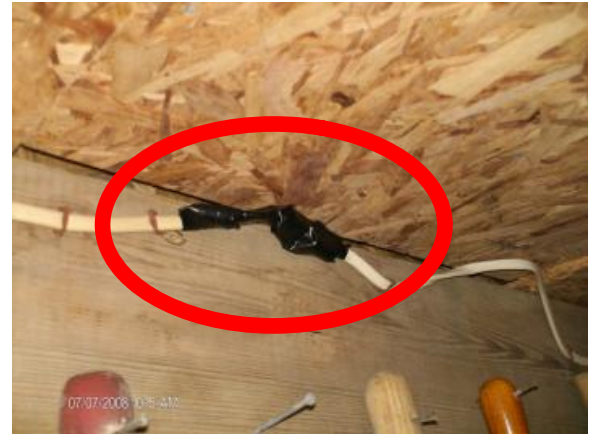
> Exposed wire splice is visible in the crawlspace that is tapped up, evaluation for correction by a qualified electrical contractor is recommended.

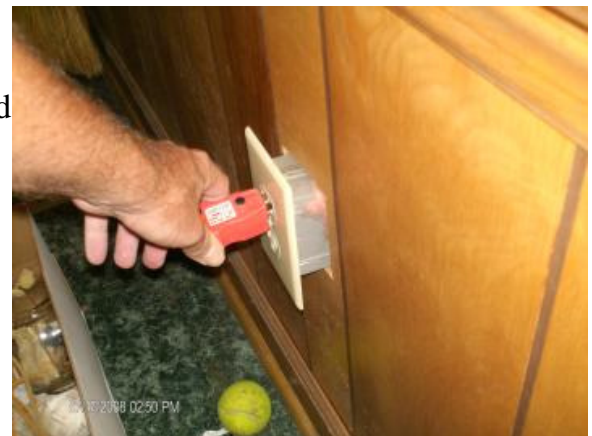
> Loose wall receptacles are noted at the back left family room, service by a qualified electrical contractor for correction is recommended.

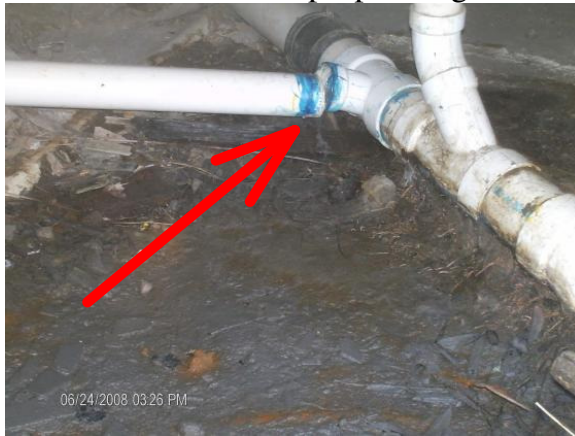
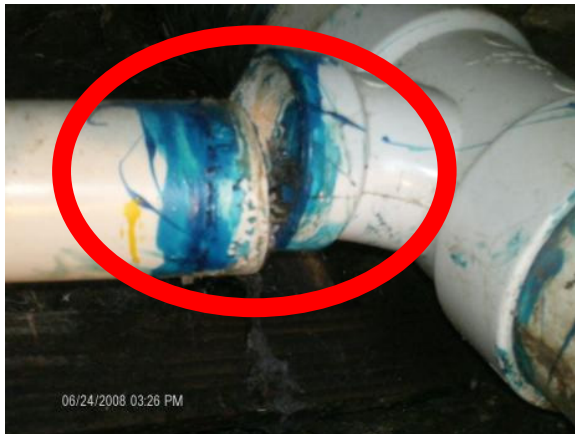
> Leaking is noted at a main waste line connection under the master bath in the crawlspace, further evaluation by a qualified plumbing contractor for corrective measures or to insure proper long term service is recommended.

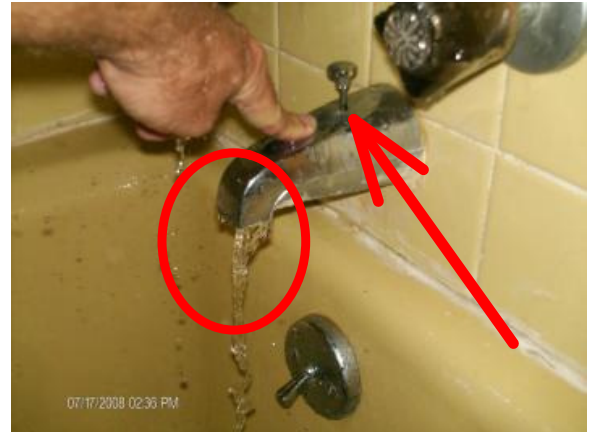
- 11. Acceptable, Repair Fixtures/Faucets:
  - > Shower diverter not allowing full water flow to the shower head in the middle bathroom, evaluation by a qualified plumbing contractor for possible correction is recommended.

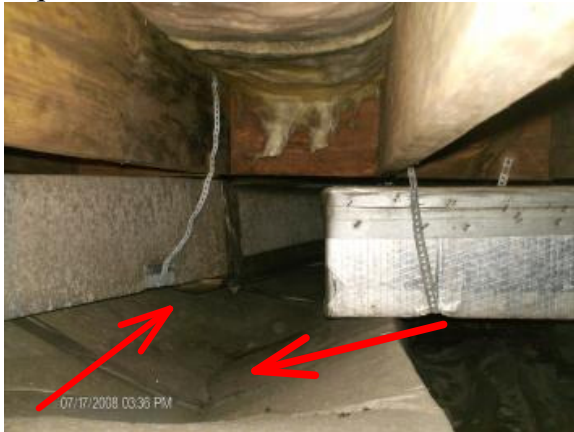
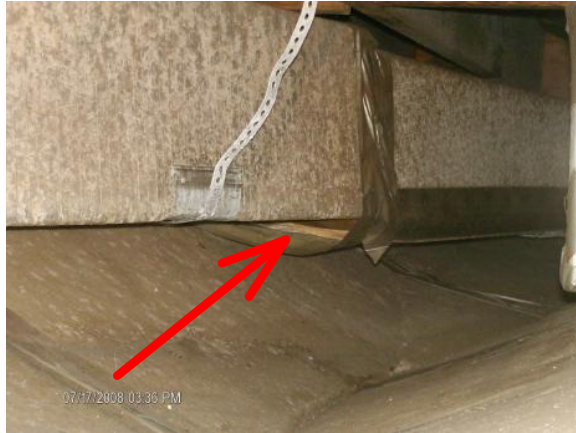
- 1. Acceptable A/C System Operation:
- 2. Acceptable AC / Heat Pump System
- 3. Acceptable Condensate Removal:
- 4. Acceptable Exterior Unit:
- 5. Area Served: Entire Home Approximate Age: Near 4 years old
- 6. Fuel Type: 120-240 VAC Temperature Differential: OK
- 7. Type: Package heating and air Capacity: 2 Ton
- 8. Not Accessible Visible Coil:
- 9. Not Present Refrigerant Lines:
- 10. Acceptable Electrical Disconnect:
- 11. Repair Distribution: Duct board material with flex supply lines>  
> Duct system has visible damage in the crawlspace and air leaks in various areas of the system is noted, also open duct seams are also visible, evaluation for correction by a qualified mechanical contractor is recommended.

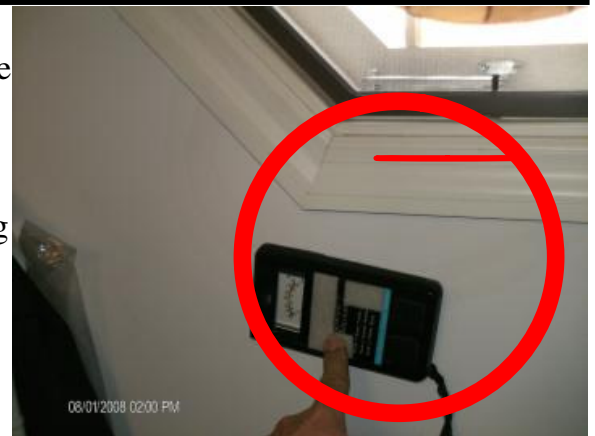
- 1. Acceptable, Repair Walls: Sheet Rock, Paneling>
  - > Evidence of past or present water leakage into the right master bedroom closet with possible hidden moisture issues, further evaluation by a qualified contractor for corrective measures or to insure proper long term service is recommended.

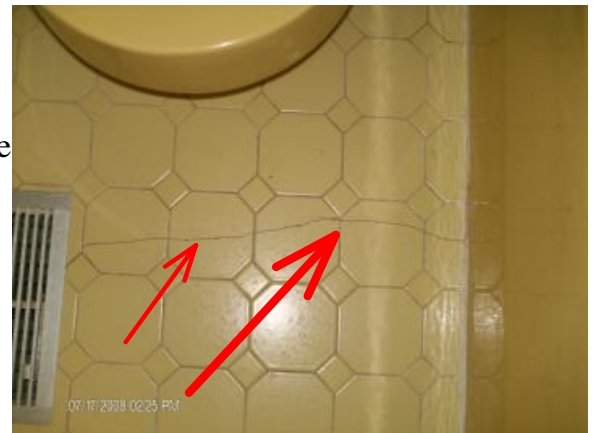
- 2. Acceptable Ceilings: Sheet rock
- 3. Acceptable, Repair Floors: Carpet, Ceramic tile, Vinyl floor covering>
  - > Ceramic tile has evidence of cracks in the middle bathroom with no lifting or loose tiles found during the inspection

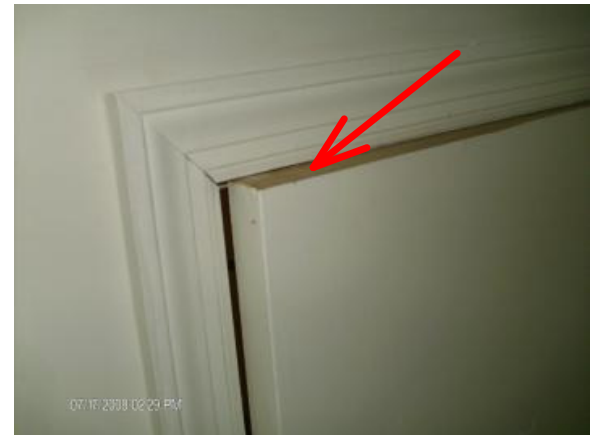
- 4. Not Present Steps:
- 5. Not Present Stairways:
- 6. Not Present Balconies:
- 7. Not Present Railings:
- 8. Acceptable Closets:
- 9. Acceptable, Repair Doors: Door not latching at the front dining and basic service to improve the door latch and striker connection is recommended.  
> Door is binding at the back right bedroom, service for general repair and proper use is recommended.

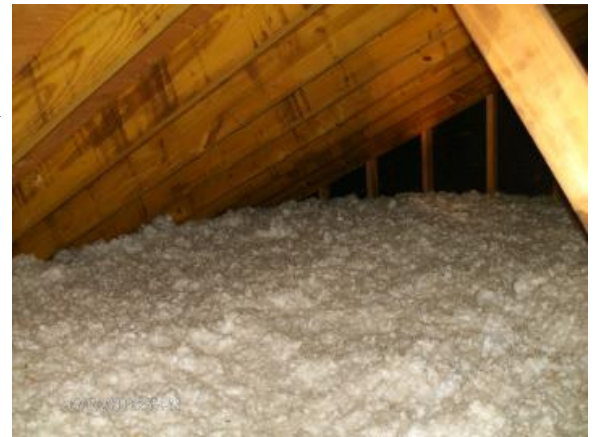
- 1. Acceptable Insulation & Venting Systems  
> The insulation and venting systems were found in very good condition at the time of the inspection.
- 2. Acceptable, Repair Bathroom Ventilation:  
> Bathroom vent in the middle bath has build in heat and found not functional, service by a qualified contractor for correction and proper long term service is recommended.
- 3. Acceptable Laundry Ventilation:

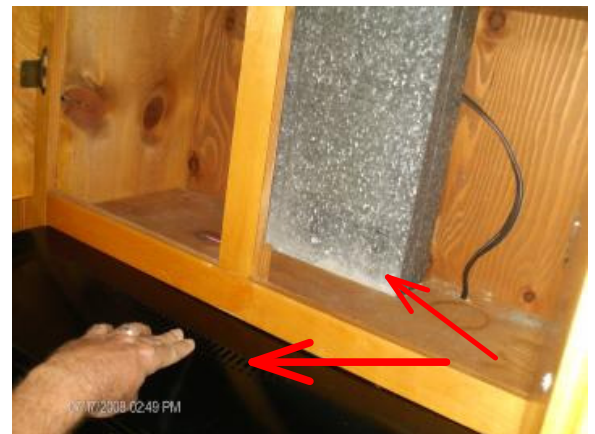
- 1. Good Condition      Kitchen & Systems  
  - > The kitchen area and systems were found in very good working condition at the time of the inspection.
- 2. Acceptable      Cooking Appliances: General Electric, Electric Stove top / oven>  
  - > Anti-tip device is not present for stove / oven and is considered unsafe for long term use, service by a qualified contractor for basic correction and safe use is recommended.
- 3. Acceptable, Repair      Ventilator: Hood vent fan with circulating motion>  
  - > Exhaust vent fan is operational but has not been vented or diverted to the back attached exhaust vent and is front venting, service by a qualified appliance contractor for possible correction to insure proper service is recommended.
