# Home Inspection Report

## Secure Home Inspections, Inc.

Property Address: 2455 North Shore Dr.  
Myrtle Beach, SC 29566

Date: 06/05/2008

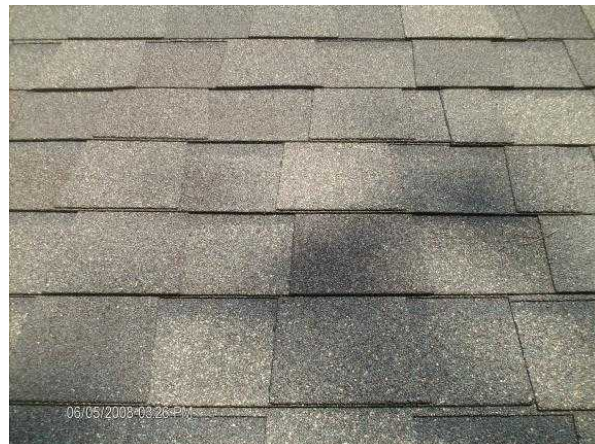
Main Roof Surface

- 2. Method of Inspection: Ladder used at various eave areas
- 3. Acceptable      Roof Coverings: Asphalt shingle

- 4.                    Type: Gable
- 5.                    Approximate Age: Estimate 1 to 2 years

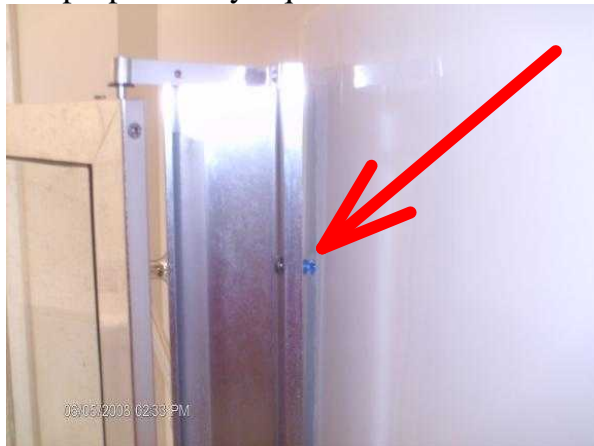
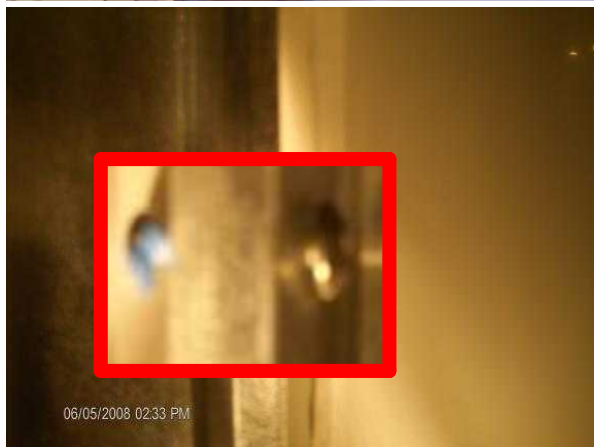
- 7. Acceptable Drain Pipes: PVC, where visible.
- 8. Not Visible Waste Drain Pipes: System appears to be draining properly at the time of the inspection.
- 9. Acceptable Plumbing Insulation:
- 10. Acceptable Pipe Supports:
- 11. Acceptable Fixtures/Faucets:
- 12. Acceptable Traps:
- 13. Acceptable Kitchen Sink:
- 14. Acceptable Bathroom Sink/Basin:
- 15. Acceptable, Repair Tub/Surround:
  - > Master shower door is loose along wall connection, further evaluation for correction and proper use by a qualified contractor is recommended.

> Master shower door is loose along wall connection, further evaluation for correction and proper use by a qualified contractor is recommended.

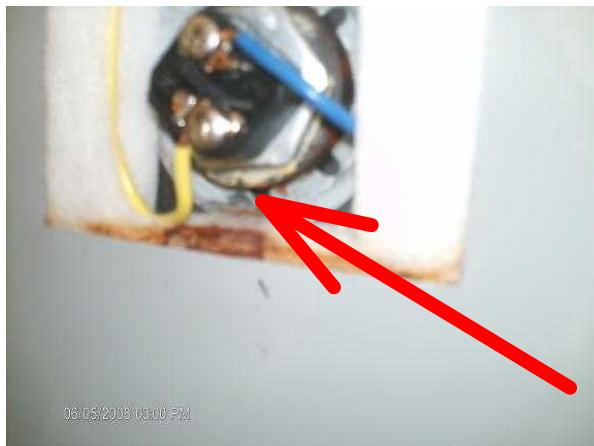
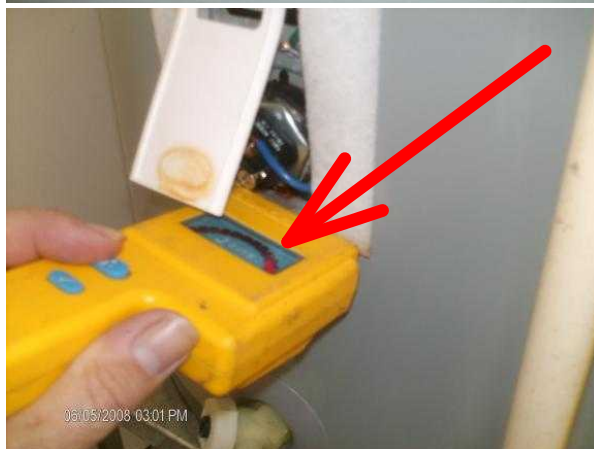
- 28. Repair Leaks:  
> Water heater is leaking at the lower element inside the enclosure, further evaluation by a qualified plumbing contractor is recommended for correction and proper long term service.

> Water heater is leaking at the lower element inside the enclosure, further evaluation by a qualified plumbing contractor is recommended for correction and proper long term service.

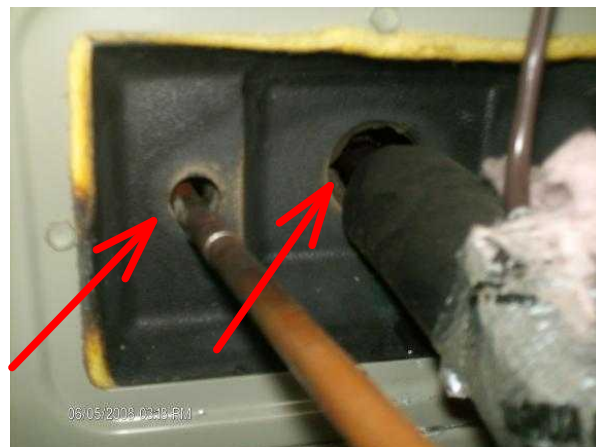
- 9. Acceptable Visible Coil:
- 10. Acceptable, Repair Refrigerant Lines:
  - > Openings around refrigerant lines at air handler, service by a qualified mechanical contractor for correction to insure proper long term service of the system is recommended.

> Openings around refrigerant lines at air handler, service by a qualified mechanical contractor for correction to insure proper long term service of the system is recommended.
